Monitoring structural cracks

Campbell Scientific equipment helps to preserve and restore an historic monument

Project area:
Castillo de San Marcos National Monument, St. Augustine, Florida, USA

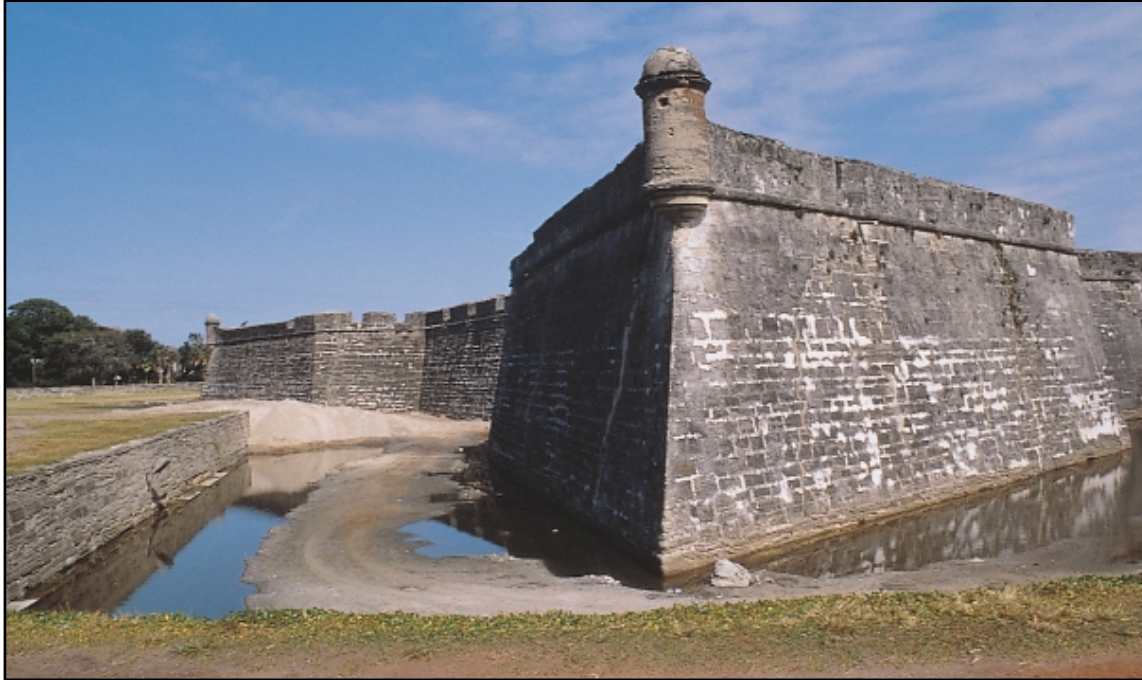
Castillo de San Marcos National Monument, St. Augustine, Florida. Taken in 1995, this view looks across the moat toward the southwest bastion, where several major cracks are visible.

The fort's bastions are earthen-filled, masonry ramparts, constructed on shallow foundations. Two of the four bastions have evidenced cracks since the early 1800s. The fort's foundations ought to be structurally sound according to an extensive investigation of both the foundations and the soil bearing capacity. An emerging theory postulates that the wall construction is near its structural limit in retaining the earth fill. Rainwater infiltration may increase the internal load on the walls, causing the structure

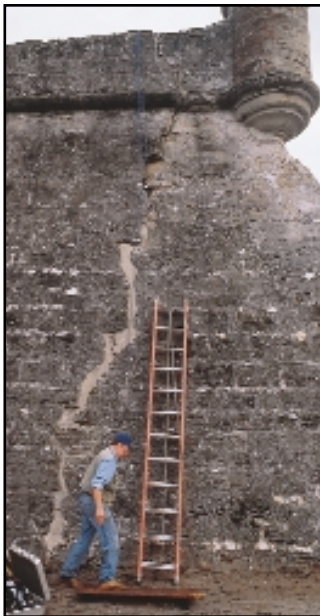
Sensors are installed across a crack in the southwest bastion.

- existing cracks in three-dimensions
- tilt of the large segments between the major cracks
- change of soil moisture with in the bastion at two levels, one near the surface and one 16 feet deep
- weather conditions at the site to assess their impact on geotechnical activity

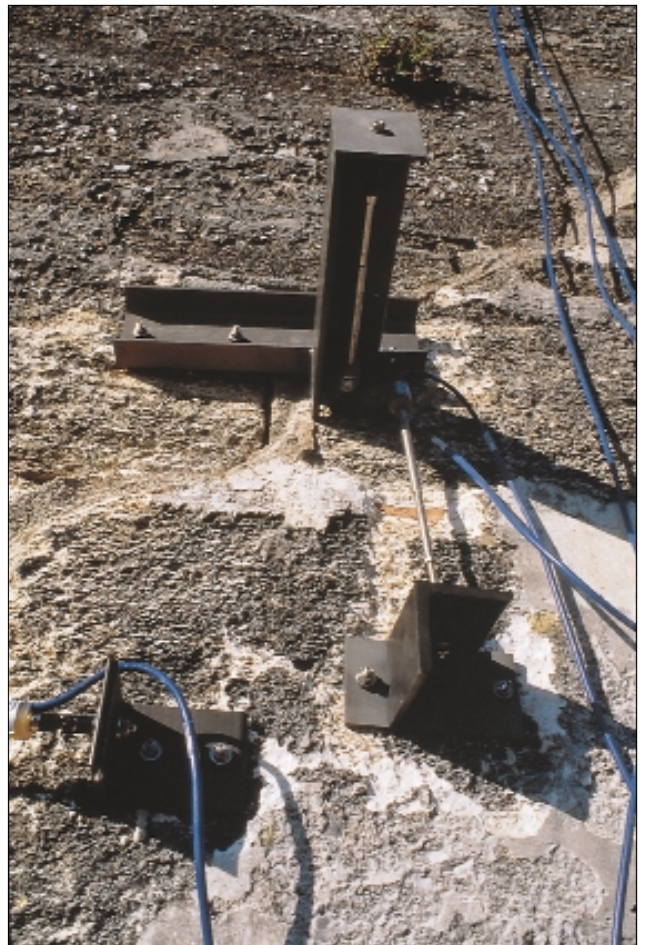
Sensors straddle cracks to directly measure displacement in each of three axes.

The equipment was integrated with crack and tilt sensors manufactured and installed by Geokon (Lebanon, NH). AMJ Equipment (Lakeland, FL) and PSI Engineering (Jacksonville, FL) provided technical and installation assistance. To reduce the installation’s aesthetic impact on the park, cables were concealed in custom conduit with the help of the park’s maintenance staff.
